STRUCTURAL ANALYSIS OF THE WALLEYE MARK 13 CONTAINER COVER

FINAL REPORT
SwRI Project 15-7958-810

United States Navy
Pacific Missile Test Center (PMTC)
Pt. Mugu, California 93042

August 1984

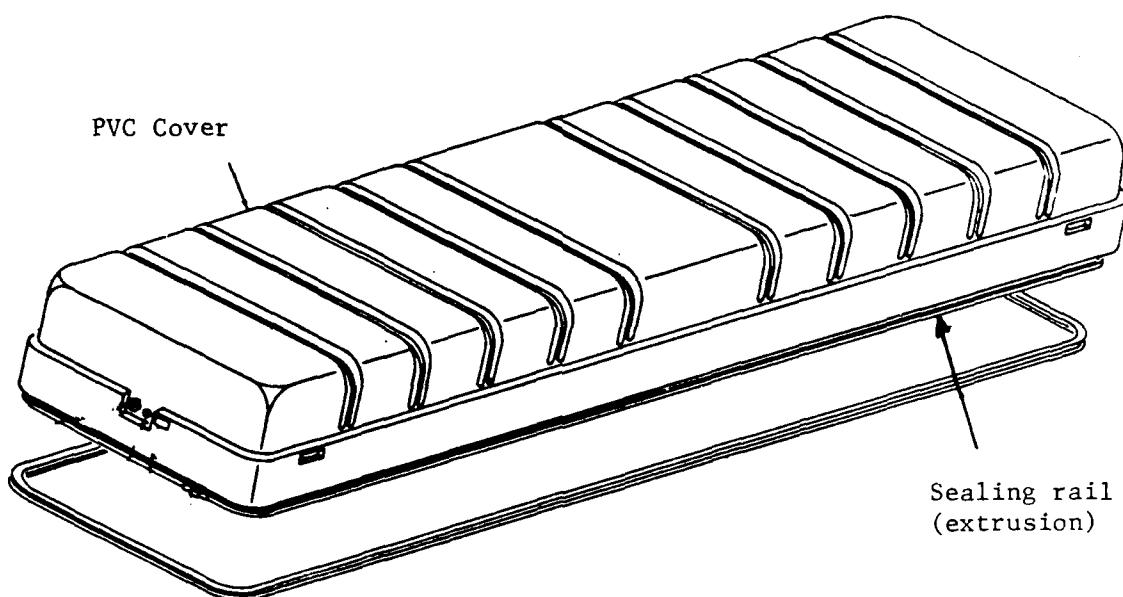
FIGURE 1. CRADLE COVER

Southwest Research Institute (SwRI) for the Pacific Missile Test Center (PMTC) was tasked to perform a structural analysis of the WALLEYE MARK 13 container cover assembly (Figure 1). Cracking of the covers has been documented by Navy personnel. Recently, a PMTC investigation [2] demonstrated that typically, new cover assemblies varied in length and width from 0.125 inches to 0.562 inches. To delineate the sensitivity of the width/length (W/L) tolerance variations to tensile or flexural failures, a finite element modeling analysis was undertaken. In addition, sample acrylic - PVC alloy material was nondestructively tested for dimensional stability and weight change at elevational temperatures.

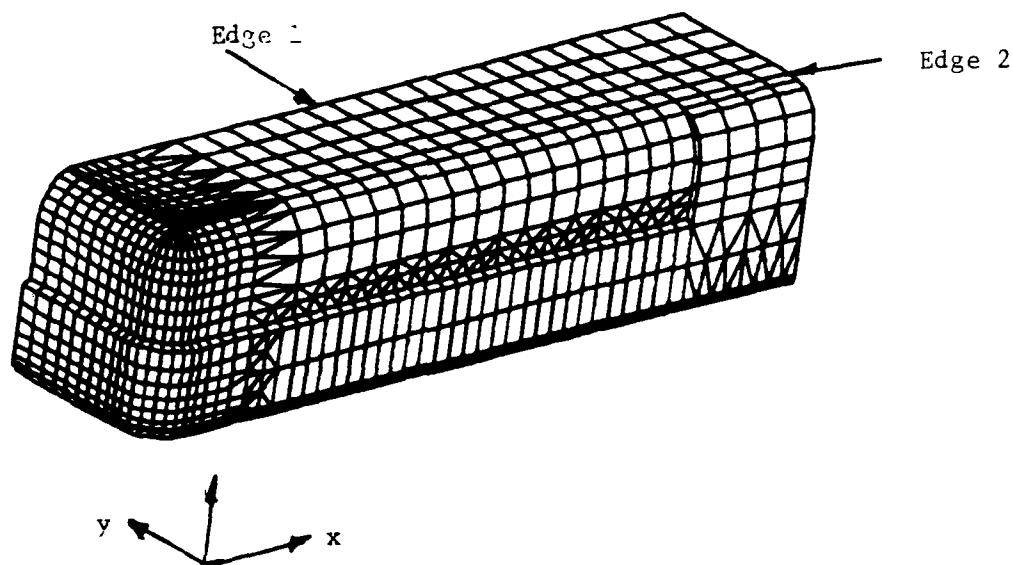
FIGURE 2. FINITE ELEMENT MODEL
(Quarter Symmetry)

To model the cover assembly SwRI utilized the MSC-NASTRAN general purpose finite element code. Because of bending induced in the cover when it is locked down upon the base [2], isoparametric four-node plate bending elements (CQUAD4) were extensively utilized in the generation of the model (Figure 2). As shown, due to the geometry of the cover, a one-quarter symmetry model of the assembly was permissible. So as to delineate any high stress gradients in the critical corner region of the cover, a finer mesh of elements was included. To model the circular ribbing across the width of the cover assembly, equivalent beam (CBEAM) elements were used. Triangular plate (CTRIA3) elements were included only for transition regions so as to reduce the number of elements in the model.

As noted, because of the geometry symmetry of the cover assembly, only one-quarter of the unit warranted modeling. To assure the appropriate structural response under a priori prescribed displacements, the boundary conditions excluded rotations about the x and z axes along edge 1 (Figure 2) and rotations about the y and z axes along edge 2. Along with these constraints, zero displacements in the y-direction along edge 1 and in the x-direction along edge 2 were imposed.

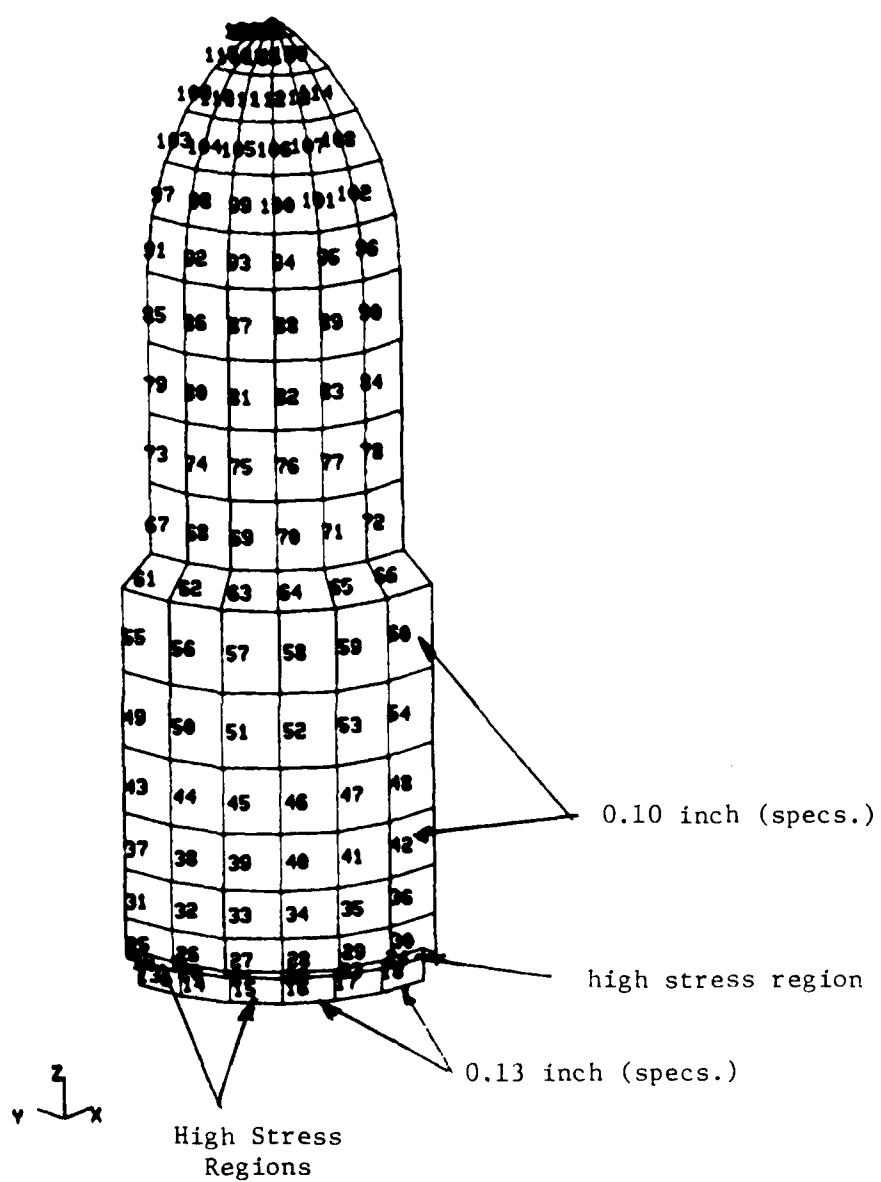
FIGURE 3. CORNER FINITE ELEMENTS

The result as given in Table 1 show a peak bending stress of 6.7 ksi at element 19 (Figure 3). With typical flexural strengths of 7.5 ksi for Royalite R57 and 9.7 ksi for Kydex 100, results from case 1 suggest that the imposed lateral (width) and longitudinal (length) displacements are not sufficient to cause failure.

Results for case 3 show a significant increase in stress concentration at two locations along the corner's edge. Element 19 with a bending stress of 8.26 ksi is 10 percent greater than the flexural strength of Royalite (R57). The peak tensile stress at element 15 is more significant. The recorded 7.64 ksi stress is 34 and 27 percent higher than the ultimate tensile strength of the Royalite and Kydex materials, respectively. It is further noted that the high tensile stress area (element 15) is at the lower edge region of the corner where the thickness specification [1] is 0.13 inches and which is encapsulated within the aluminum sealing rail (extrusion). Crack repair in this region may be difficult if at all possible.

In case 8, elements 13 through 36 (Figure 3) were increased in thickness by 50 percent, viz., 0.13 inches to 0.20 inches and the 0.10-inch specification to 0.15 inches. In this instance there was a reduction in corner peak stress levels. At the lower edge (element 15), the stress was reduced by 17 percent while the stress at element 24 was reduced by 11

In the last simulation case (9), the lower edge thickness (elements 13 through 18, Figure 3) was 0.25 inch while the adjacent thickness was defined at 0.20 inches (elements 19 through 36). This increase in corner thickness resulted in a 24-percent decrease in concentrated stress in element 24 and a 26-percent decrease in stress at element 15. With respect to W/L tolerances for the cover this equates to 0.452 inch variation* between cover and base assembly which will fail the cover during latching procedures.

For future cover manufacturing, a design specification of 0.20 inches in lieu of 0.13 inches [1] for the corner regions would significantly help in reducing, if not eliminating, the number of cover failures.

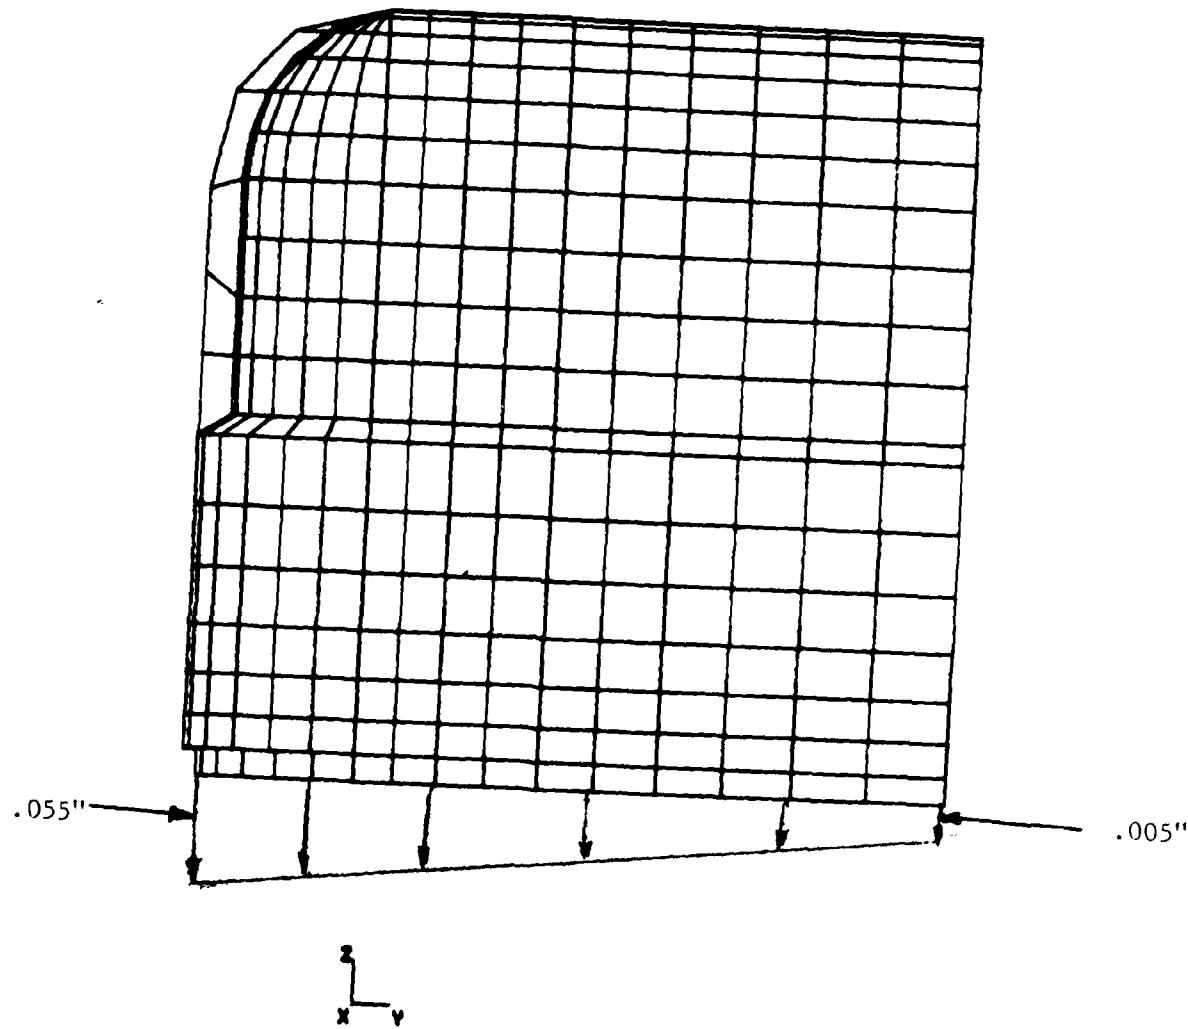
FIGURE 4. WIDTH EDGE WARPING

Because of the above, case 2 was run to consider cover edge warping effects in addition to the width/length (W/L) variations. As shown in Table 1, when the cover width edge (Figure 4) had an imposed vertical displacement from .005 to 055 in., the resultant peak stress level increased to 8.39 ksi (element 19). While this equates to apparently a 24 percent increase in stress over case 1, it was considered unlikely to be a major contributing factor in causing the documented failures.
